TEST REPORT

<hr/> James Derby Technical Manager
Checked:	Authorised:
Product: TC2 Micro	Customer: National Grid US
SUBJECT: TC2 Micro Prototype Test

TC2 Micro Prototype Test

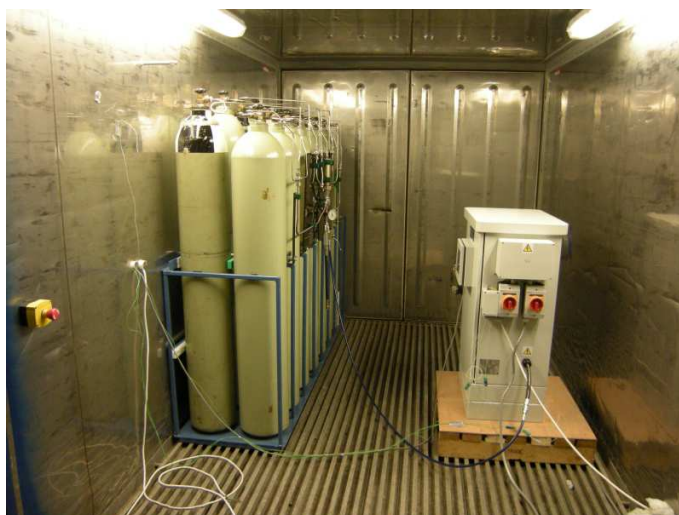
Figure 2: UUT in Environmental Chamber

The UUT was installed within the environmental chamber. Temperature setpoints & soak times were applied and measurements taken. Appendix A details the log history. No functional issues arose during the testing. The LCD display was found to washout at the colder temperatures. The LCD contrast pot was set to maximum before the final cold test and the display was found to be easily readable.

- LCD display contrast ‘pot’ should be set to maximum for cold weather operation

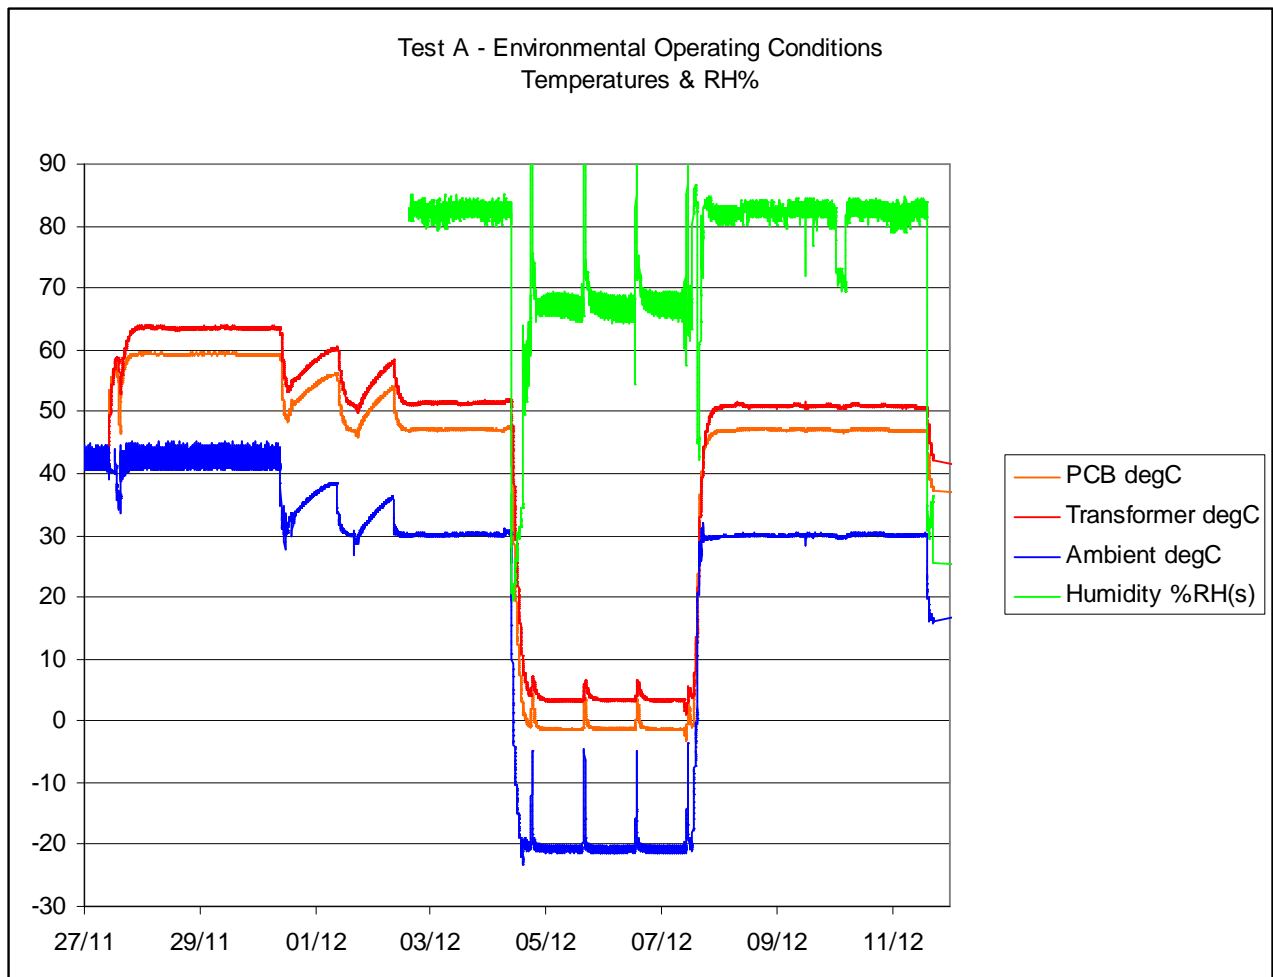
Figure 3: Showing temperature & humidity profile during Test A. Note: RH sensor not logged during initial testing.

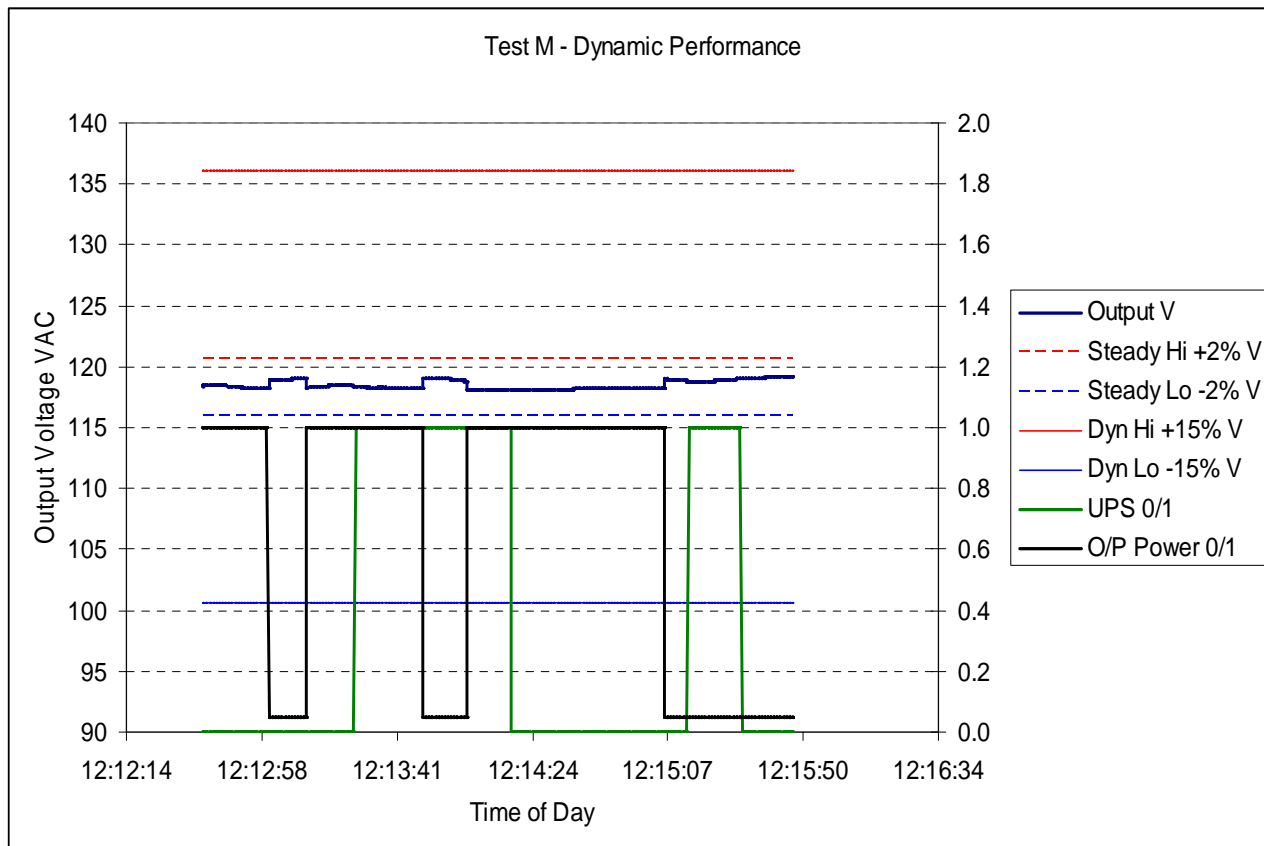
Maximum voltage variation occurred with changes to output load. The measured output voltage variations fell well within the performance class limits.

Maximum measured variation @ steady state = $\pm 0.2\%$ VAC ($\pm 2\%$ limit Class 2)

Maximum measured variation @ dynamic = $\pm 0.7\%$ VAC (15% limit Class 2 with <0.7s recovery)

Figure 4. Measured output voltage during Steady State and Dynamic Performance Class tests
